CASTLE HOME INSPECTION

RESIDENTIAL INSPECTION COPY

123 Castle Home Inspection Drive
Aurora, IL 60503

12/29/2024

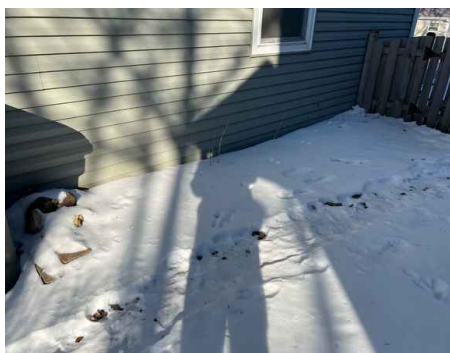
Foundation: Foundation not all visible due to snow covering

Due to snow cover, comments and ratings only reflect the visible portions of the foundation.

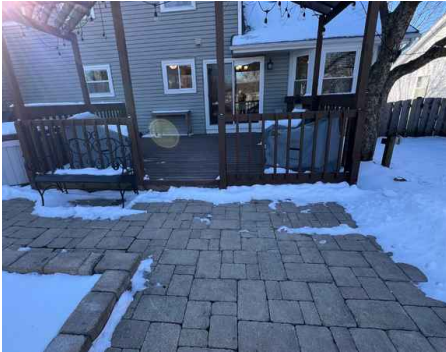
Decks: Built on/close to grade

Deck built on or close to grade, unable to inspect the underside structure. Proceed as needed.

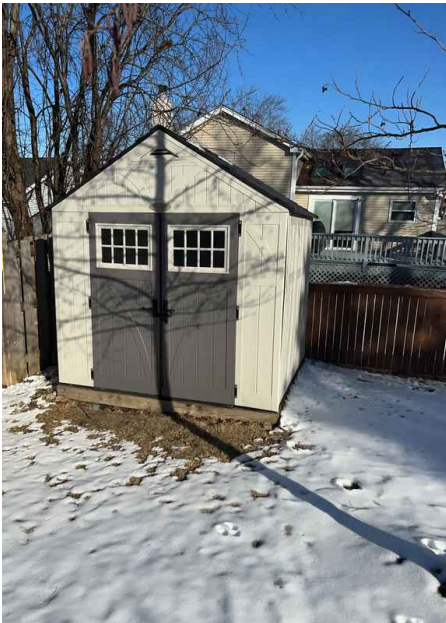
**Shed: Items stored in shed**

Due to items stored in shed, not all visible or accessible to inspect.

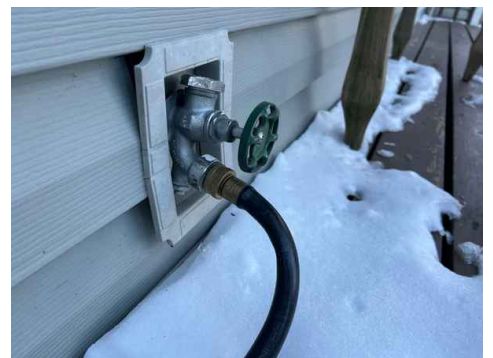
NORTH SIDE

Hose is stuck on spigot and too cold to test, (potential to freeze).
Unable to inspect function. Proceed as needed.

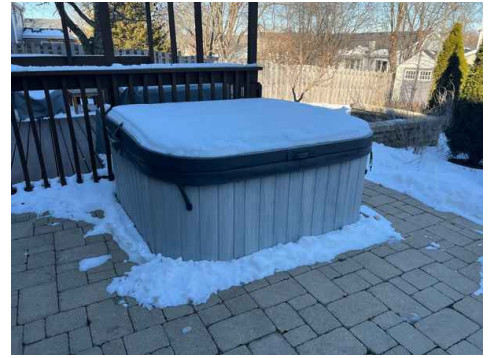
HOT TUB AND HOT TUB EQUIPMENT NOT INSPECTED

Hot tub and hot tub equipment not inspected. Beyond the scope of standard home inspection. Seller disclosed heating element is not functioning properly. Recommend specialist check and evaluate as needed prior to closing.

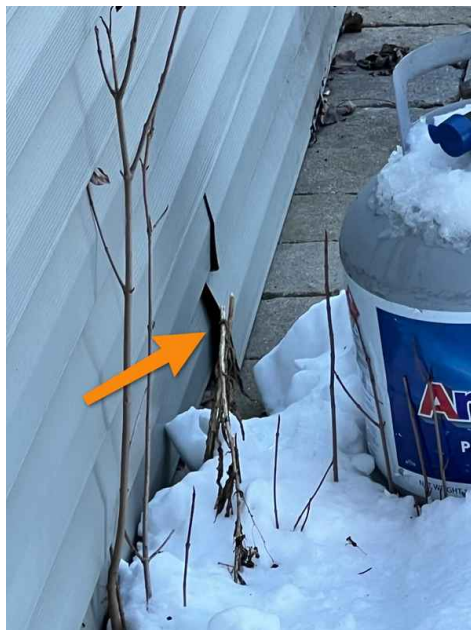
DAMAGED OR LOOSE SIDING

Contact a qualified siding specialist.

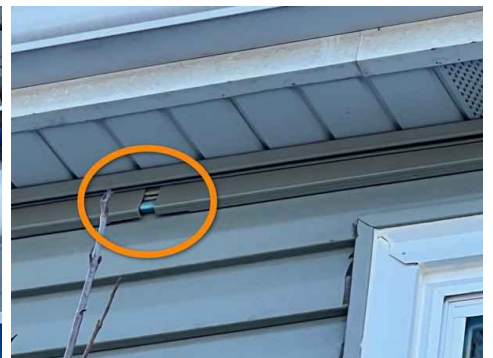
4.6.2 Siding

ADDED CAULK AT WINDOWS/DOORS

NORTH SIDE

Caulk has been added around windows and patio door at North side of house (prior leaks?). Recommend asking seller for reason caulk was added and proceed as needed to prevent future leaks.

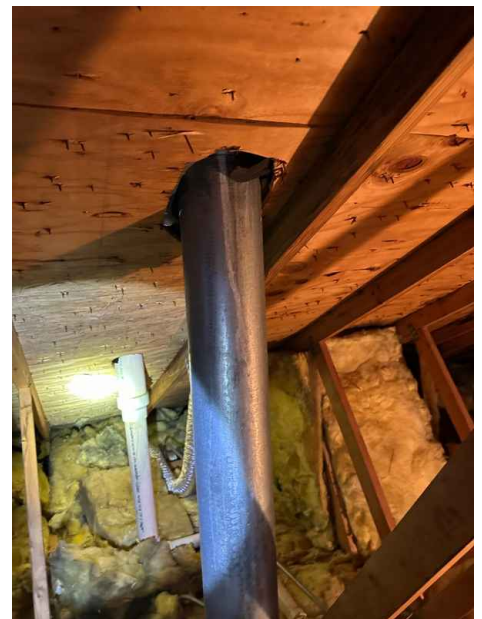
**Chimneys/ Furnace vent pipes:
Furnace vent inspected**

Photo of furnace vent pipe at time of inspection. Proceed as needed.

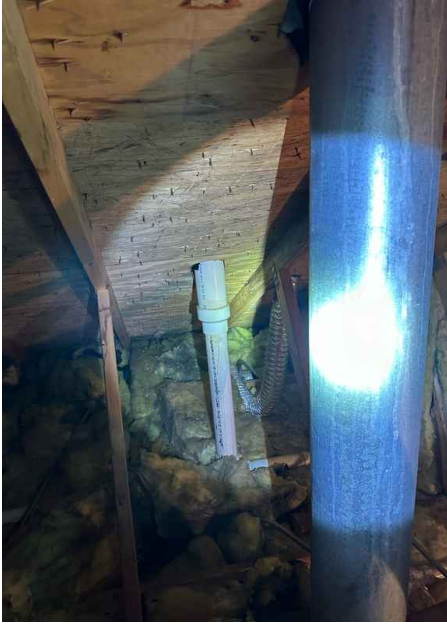
Plumbing/radon vents: Plumbing/radon vent pipes inspected.

All plumbing/radon vent pipes are inspected as long as they are visible.

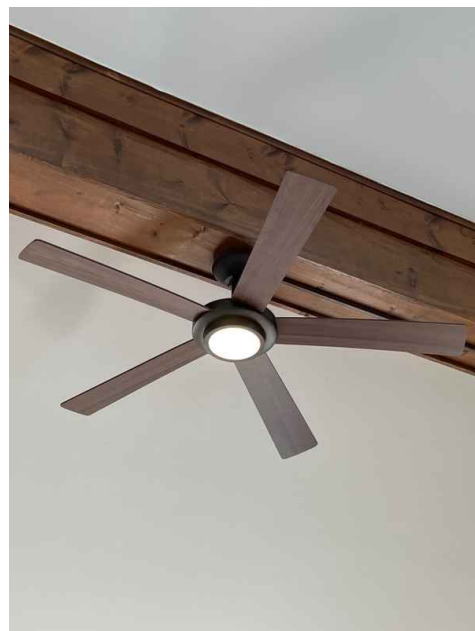
NO REMOTE FOR CEILING FAN

No remote visible to test ceiling fan. Recommend asking seller for remote and making sure operational prior to closing. Proceed as needed.

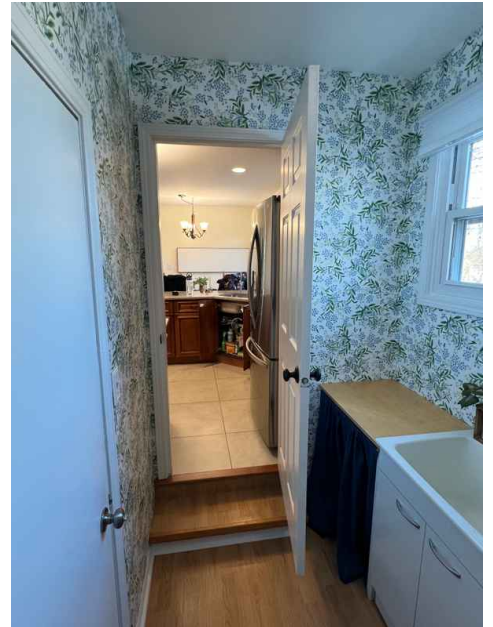
8.2.1 Doors

LAUNDRY ROOM

Door opens up over stairs, potential safety. Proceed as needed.

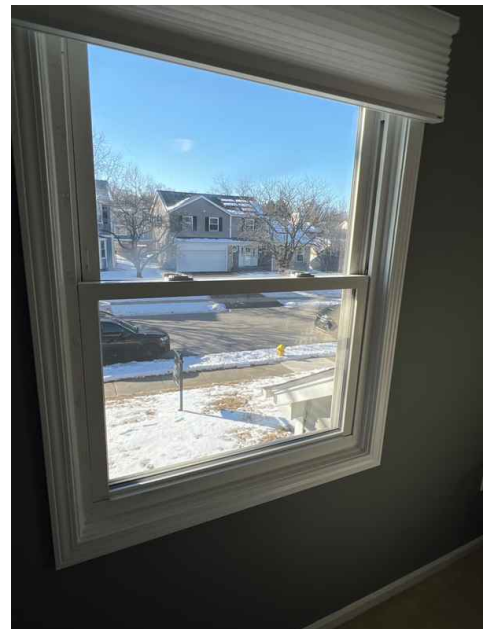
8.3.4 Windows

WINDOW(S) NOT STAYING UP, (SAFETY).

Window(s) not staying up, (safety). Recommend repairs as needed.

Contact a qualified window repair/installation contractor.

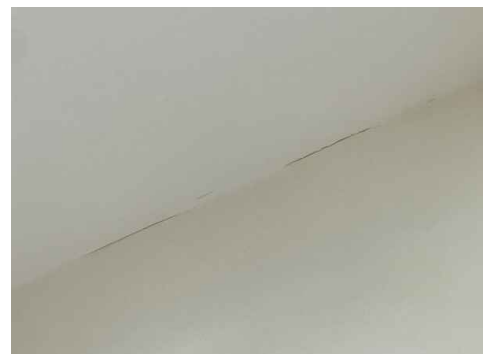
8.4.1 Walls & Ceilings

CRACKED OR LOOSE TAPE NOTED AT WALL/CEILING JOINTS.

Cracked or loose tape joints noted on ceiling. Recommend repairs as needed.

Contact a qualified drywall contractor.

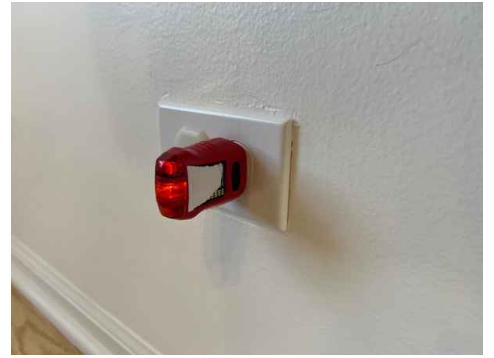
8.6.1 Electric, outlets and lighting

REVERSE POLARITY NOTED ON OUTLET(S).

Reverse polarity noted on outlet(s). Recommend having checked and repaired as needed.

Contact a qualified professional.

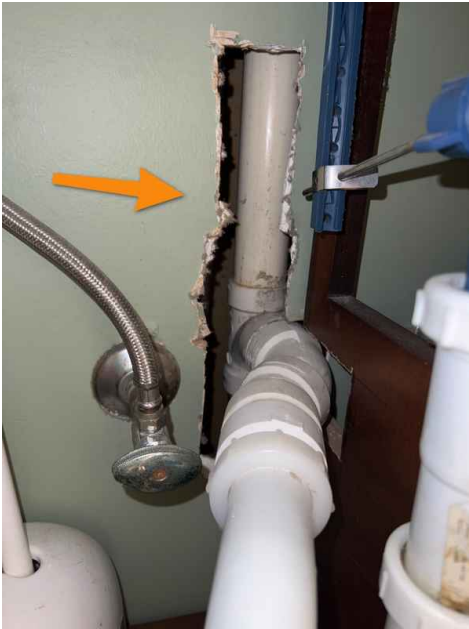
1/2 BATHROOM

Wall was opened up under sink, recommend asking seller if any repairs performed. Proceed with drywall repair as needed.

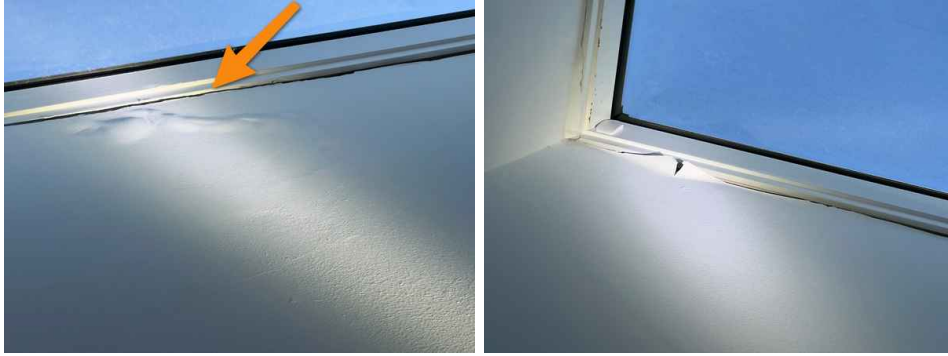
MOISTURE DAMAGE ON WALL

Moisture wear or damage noted on wall at skylight chase. Recommend having checked and evaluated for repairs as needed.

Contact a qualified professional.

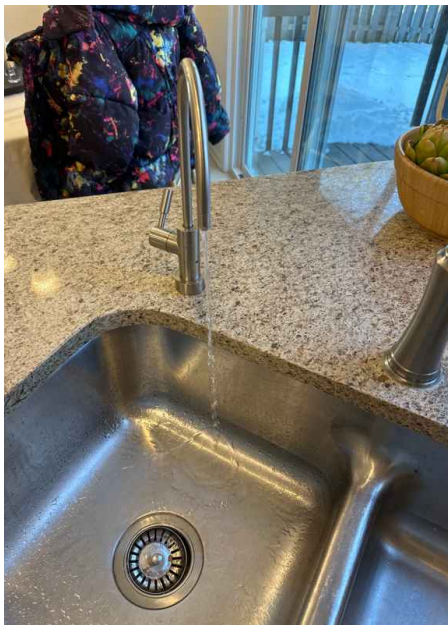
Sink/basin/faucet: Filtered faucet working at inspection

Filtered faucet working with no visible leaks present at inspection. Recommend changing filters as needed. Quality of water not inspected.

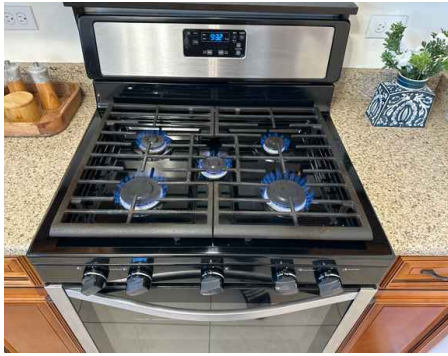
Cooking appliances: Burners working

Burners were working and oven(s) heated up at inspection. Make sure all are still operational at final walk through. Proceed as needed.

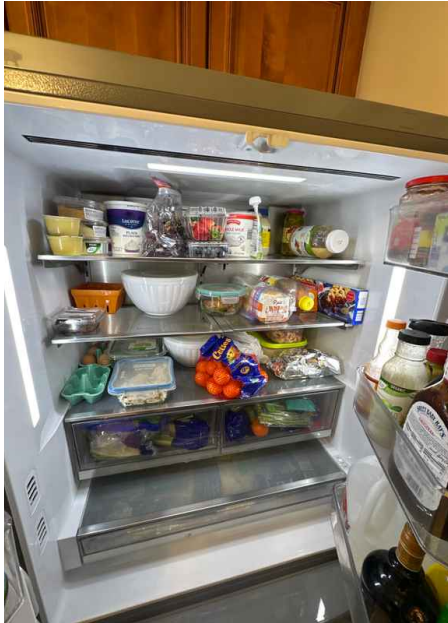
Refrigerator: Fridge/ice/water working

Refrigerator and water dispenser were operational at this time. Ice make appears to be operational. No active visible leaks noted at this time. Make sure still operational at final walk through. Proceed as needed.

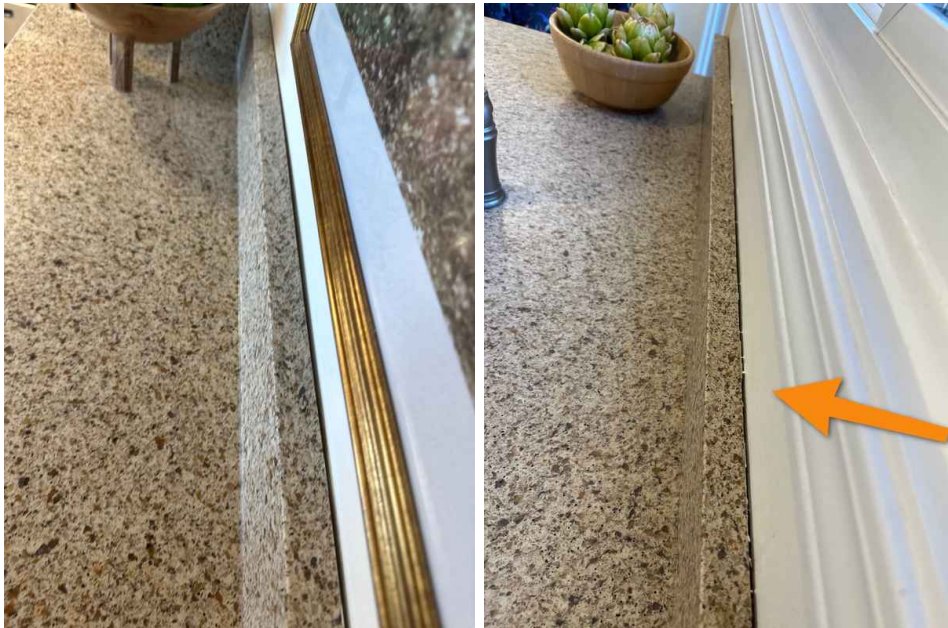
Gap at back splash and wall, recommend caulking to prevent water entry. Proceed as needed.

Contact a qualified professional.

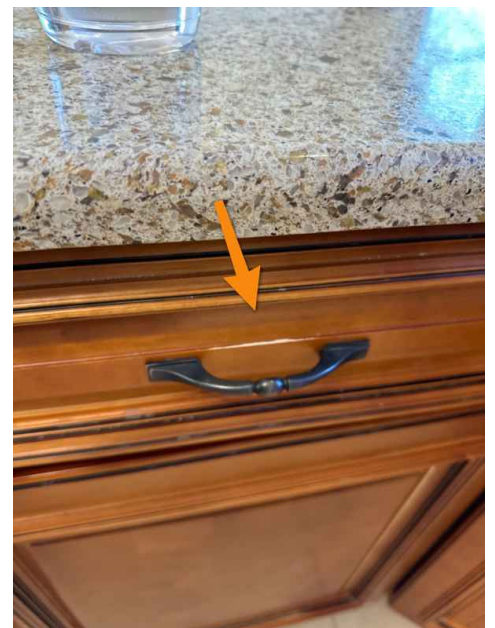
FINISH WEAR/DAMAGE IN CABINETS

Finish wear or damage noted on drawer(s) or cabinet(s). Recommend repair as needed.

Contact a qualified professional.

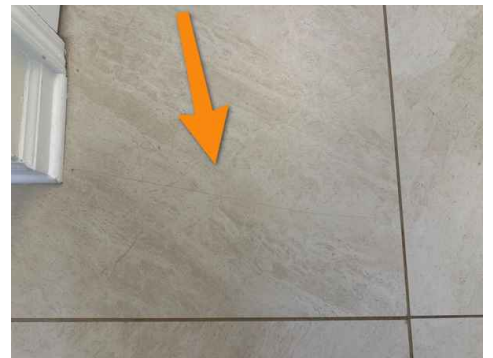
CRACKED OR LOOSE TILES NOTED.

Cracked or loose tiles noted. Recommend repairs as needed.

Contact a qualified professional.

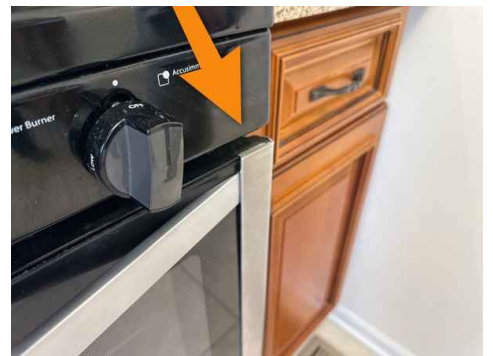
10.8.1 Cooking appliances

LOOSE TRIM

Loose trim on oven door. Recommend repairs as needed.

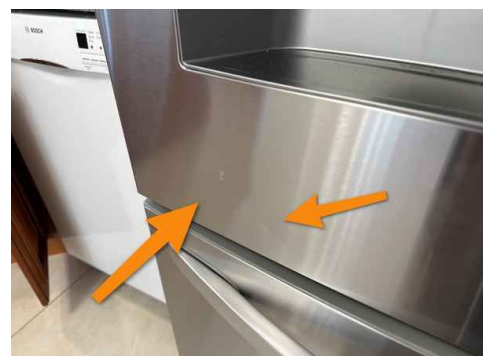
DENTS/DAMAGE ON DOOR(S)/DRAWER(S)

Dents/damage noted on door(s) or drawer(s). Recommend having checked and repaired as needed.

Contact a qualified professional.

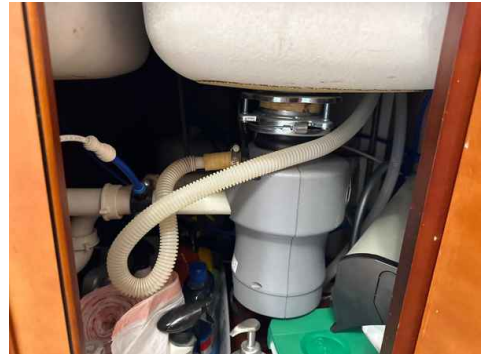
Dishwasher is draining into disposal, potential for cross contamination. Recommend plumbing contractor check and advise. Proceed as needed.

Contact a qualified professional.

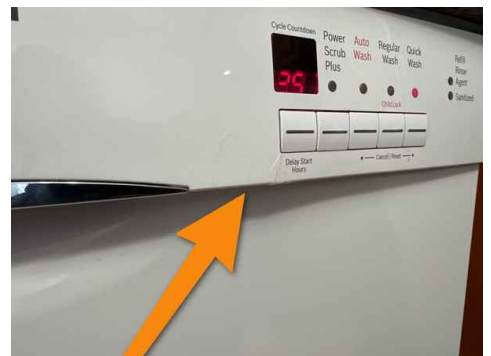
10.10.2 Dishwasher

WORN/DAMAGED BUTTONS CONTROL PAD

Worn or damaged buttons noted on control pad. Recommend repair or replacing as needed.

Contact a qualified professional.

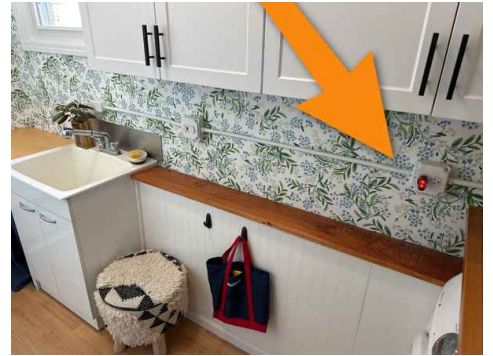
Outlets are not GFCI protected. Recommend installing GFCI outlets where needed.

Contact a qualified professional.

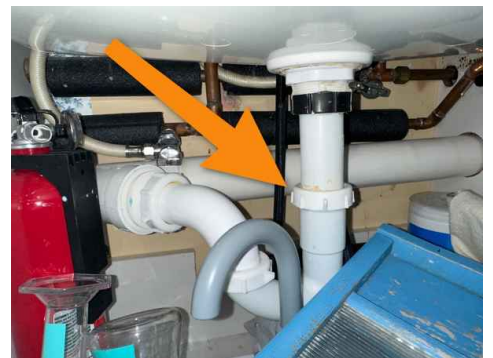
11.2.1 Laundry sink/basin/plumbing

STAINS/CORROSION NOTED ON DRAIN CONNECTION(S).

Stains or corrosion noted on drain connection(s). No active visible leaks noted at this time. Repair as needed.

Contact a qualified professional.

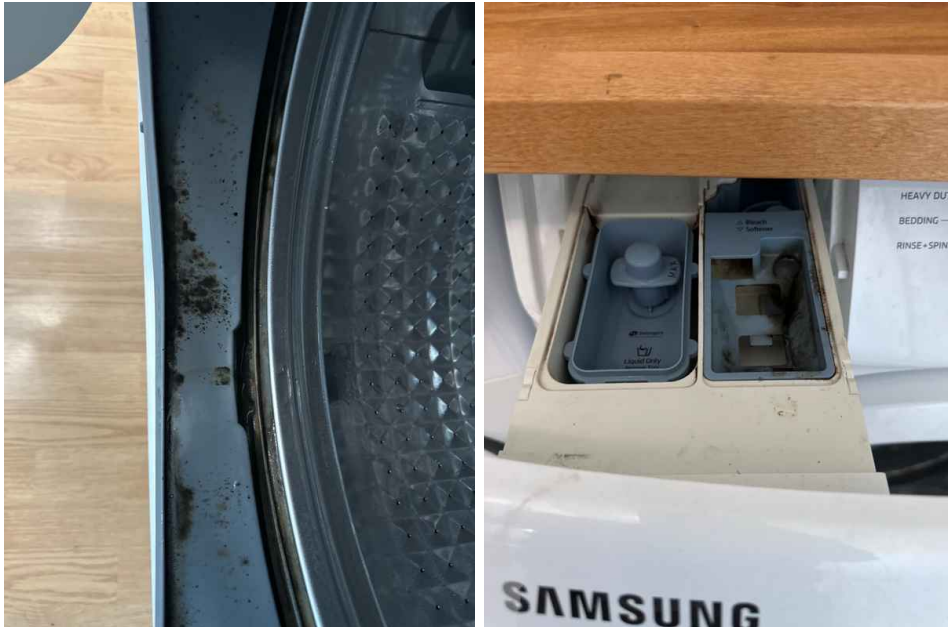
SUSPECT MOLD LIKE SUBSTANCE NOTED ON WASHER DOOR GASKET AND INSIDE DETERGENT DISPENSER.

Suspect mold like substance noted on washer door gasket and inside detergent dispenser. Recommend having removed and sanitized.

Contact a qualified appliance repair professional.

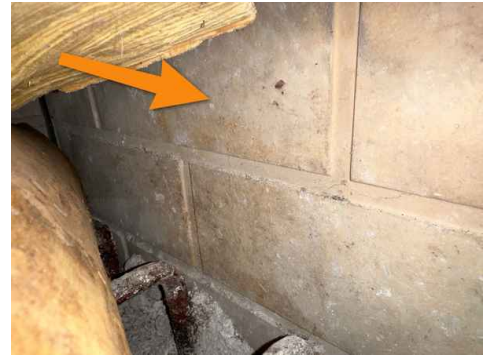
CRACKS NOTED ON REFRACTURE PANEL(S).

Contact a qualified fireplace contractor.

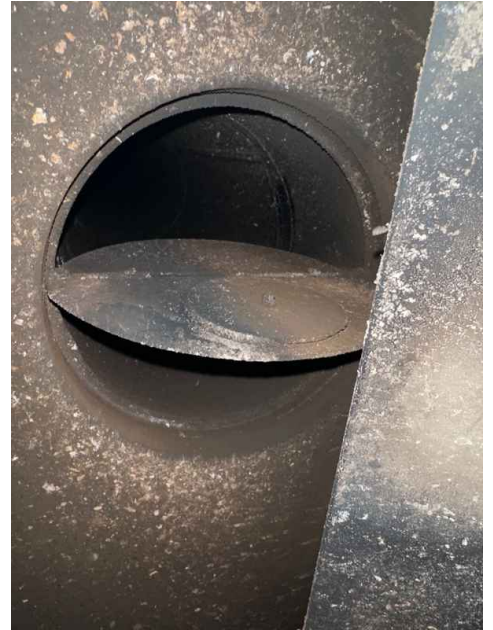
12.3.1 Overall fireplace condition

CARBON BUILD UP NOTED IN SMOKE CHAMBER AND FLUE.

Carbon build up noted in smoke chamber and flue. Recommend having cleaned and evaluated prior to closing. Proceed as needed.

Contact a qualified chimney sweep.

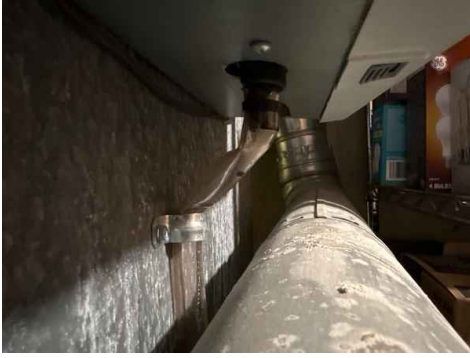
DRAIN HOSE IS KINKED

Drain hose is kinked. Recommend repairs as needed.

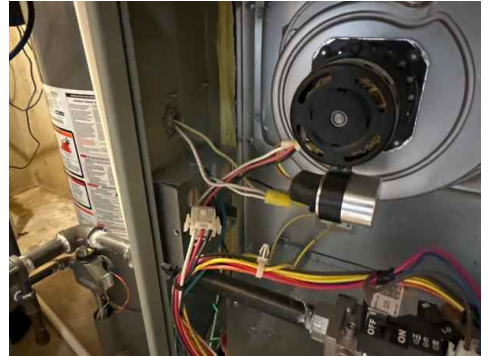
13.9.1 Additional comments

WIRE CONNECTIONS

Wire connections noted inside furnace cabinet. Recommend repairs as needed.

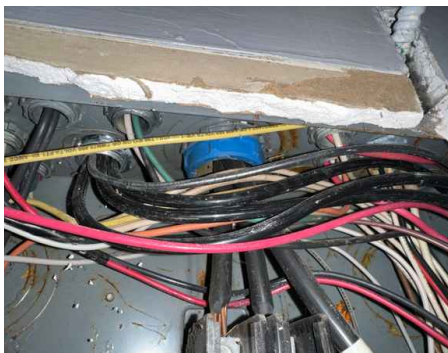
Main Panel: Recommend sealing service conduit

Recommend sealing main service conduit opening in panel to help prevent potential pest entry, draft, condensation and/or rust.

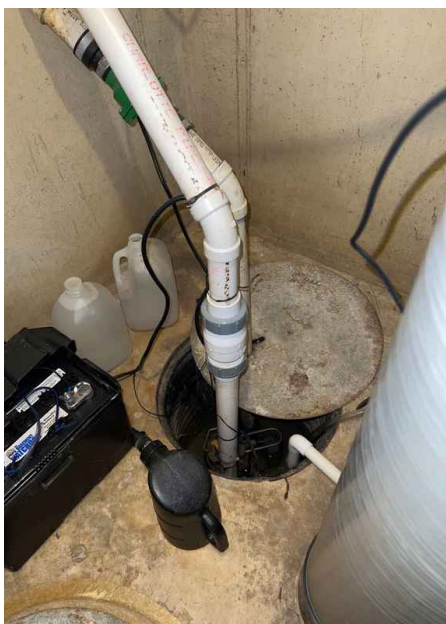
Sump pump: Sump operational

Sump pump operational at time of inspection. Be sure to check operation periodically. Pumps can fail at anytime.

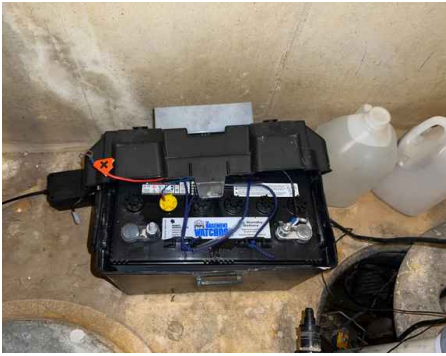
Sump pump: Back up system not in service

The battery backup system is not in service. Recommend asking seller reason why and if system works. Proceed as needed.

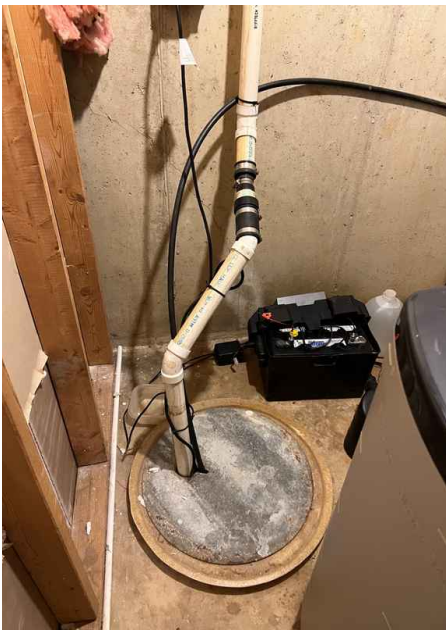
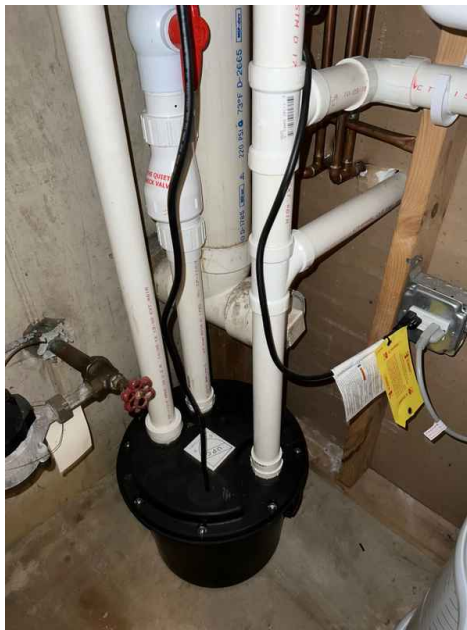
**Ejector/lift pump: Ejector/lift pumps operational**

Ejector/lift pumps operational at time of inspection. Be sure to check operation periodically. Pumps can fail at anytime.

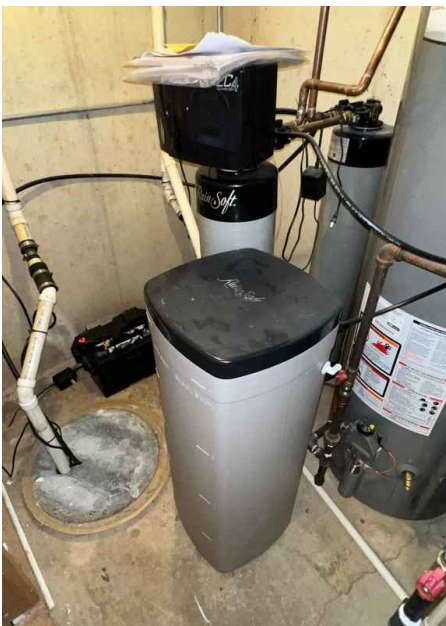
**Water softener/conditioner: Only inspected for leaks**

The water softener(if present) was only inspected for leaks (unit was unplugged) The operation and quality of the unit was not inspected.

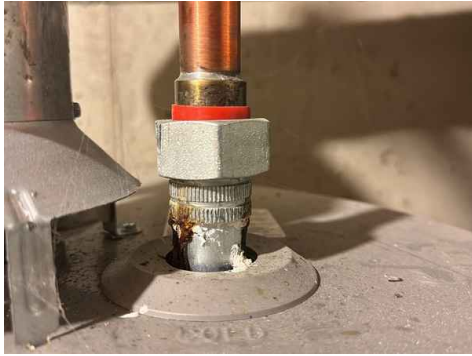
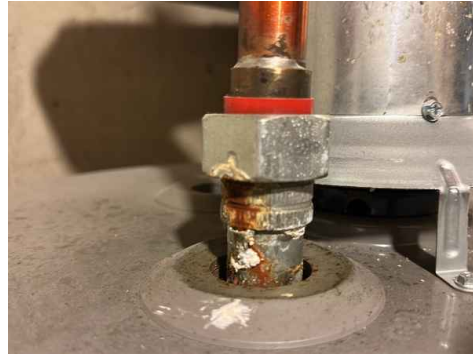
18.3.1 Overall condition

RUST/CORROSION ON UNIONS

Rust/corrosion noted on union(s) at top of tank. No active visible leak noted at this time. Recommend having checked and repaired as needed.

Recommendation

Contact a qualified professional.

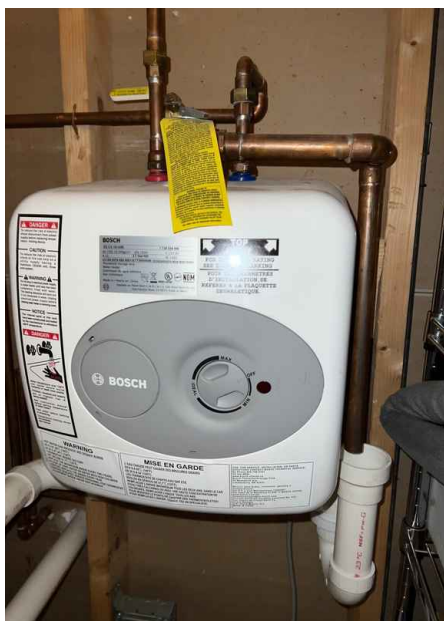
Photo of water heater

Water heater is shutoff, not able to inspect. Recommend asking seller to turn on and make sure operational prior to closing. Proceed as needed.

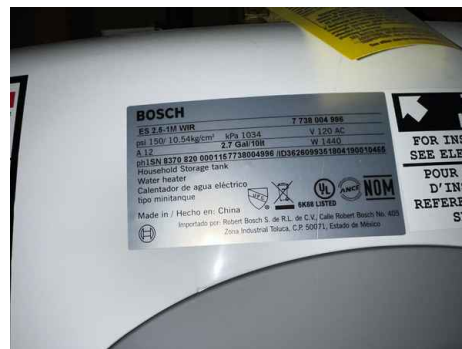
Model/Serial Number/Data tag

Tankless unit

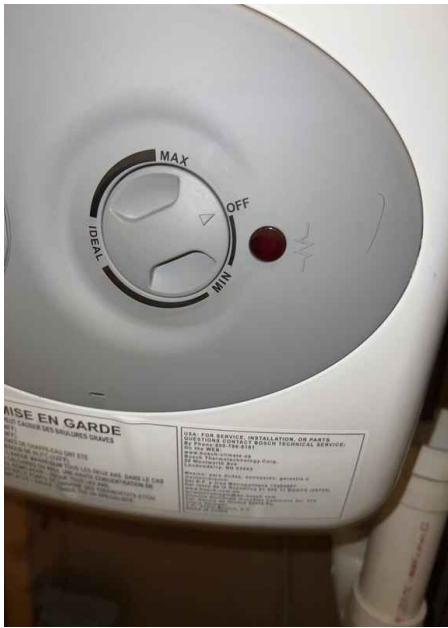
Unit is shutoff not inspected

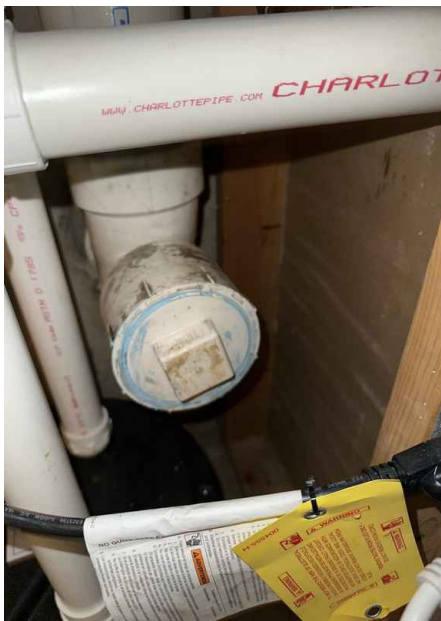
Access/cleanout condition: No defects at cleanout

The clean out was in normal working condition with no visible defects.
